Accident: Wing detached from ICP Savannah 912.

Date: 29. June 2005

Place: Lakselv, Northern Norway

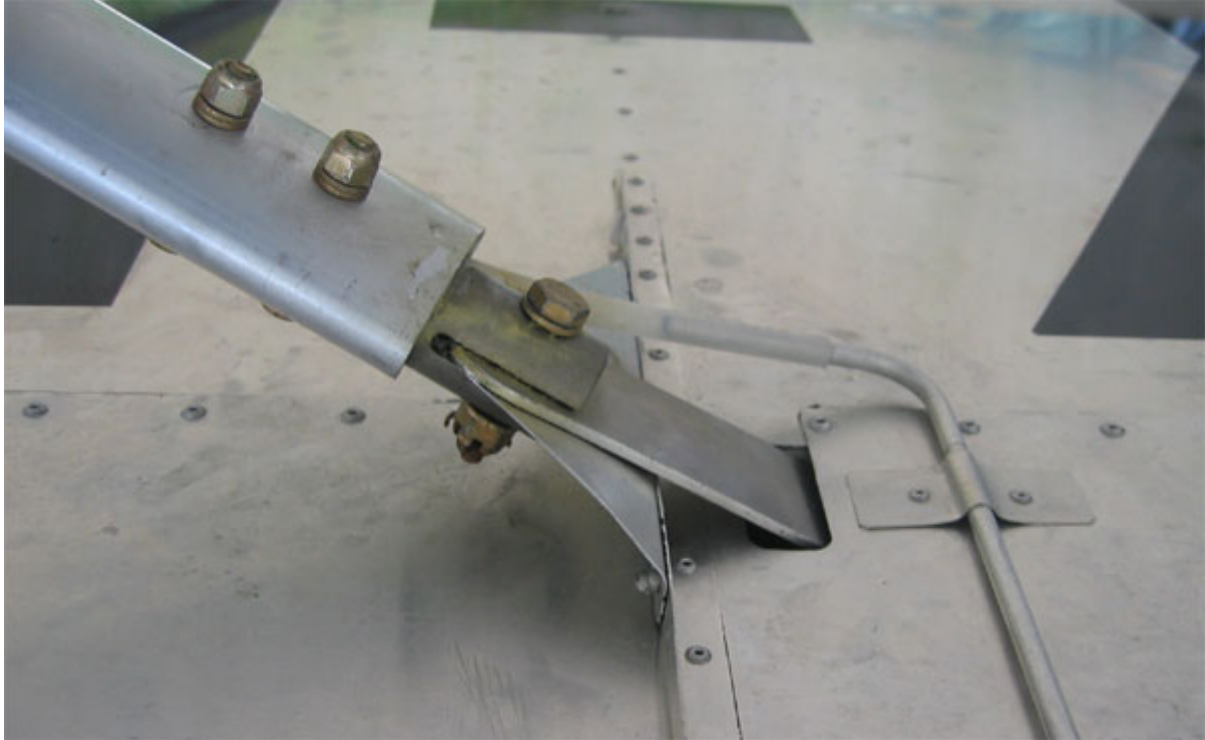
Picture 1: Main wing strut connection plate into the wings main beam. This picture shows an ICP Bingo, which seems to have an identical construction. Picture has been flipped over to resemble picture below.

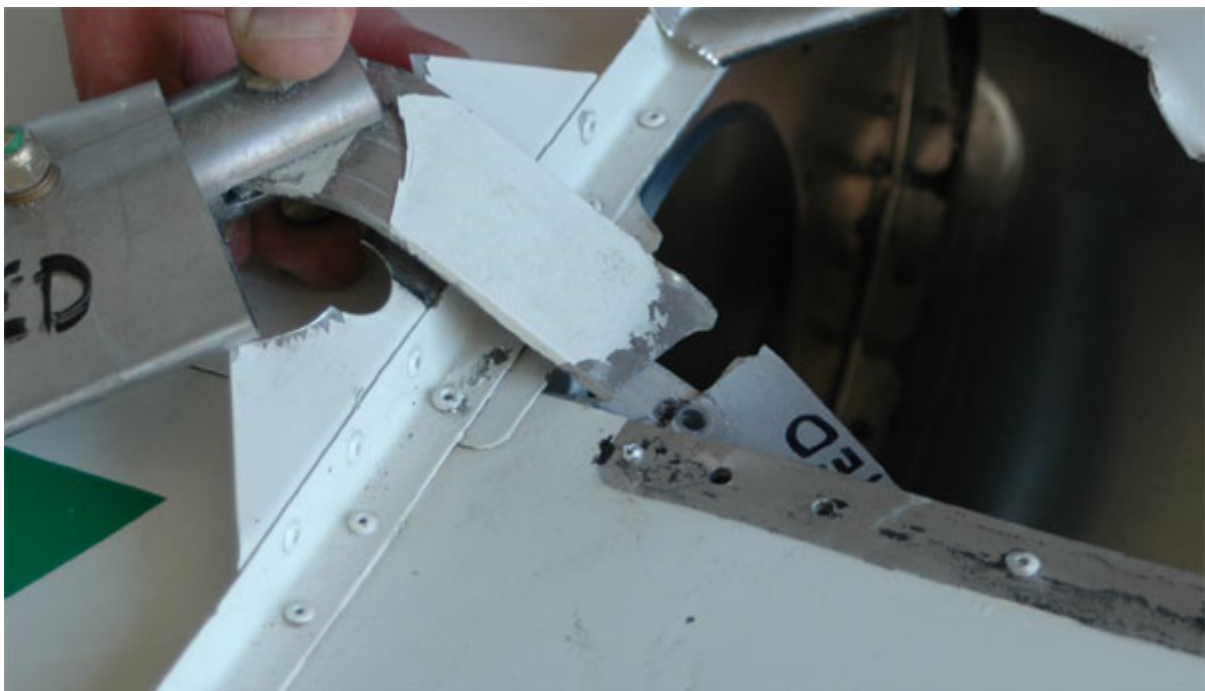
Picture 2: How the connection plate broke near the first bolt at the left-hand wing.

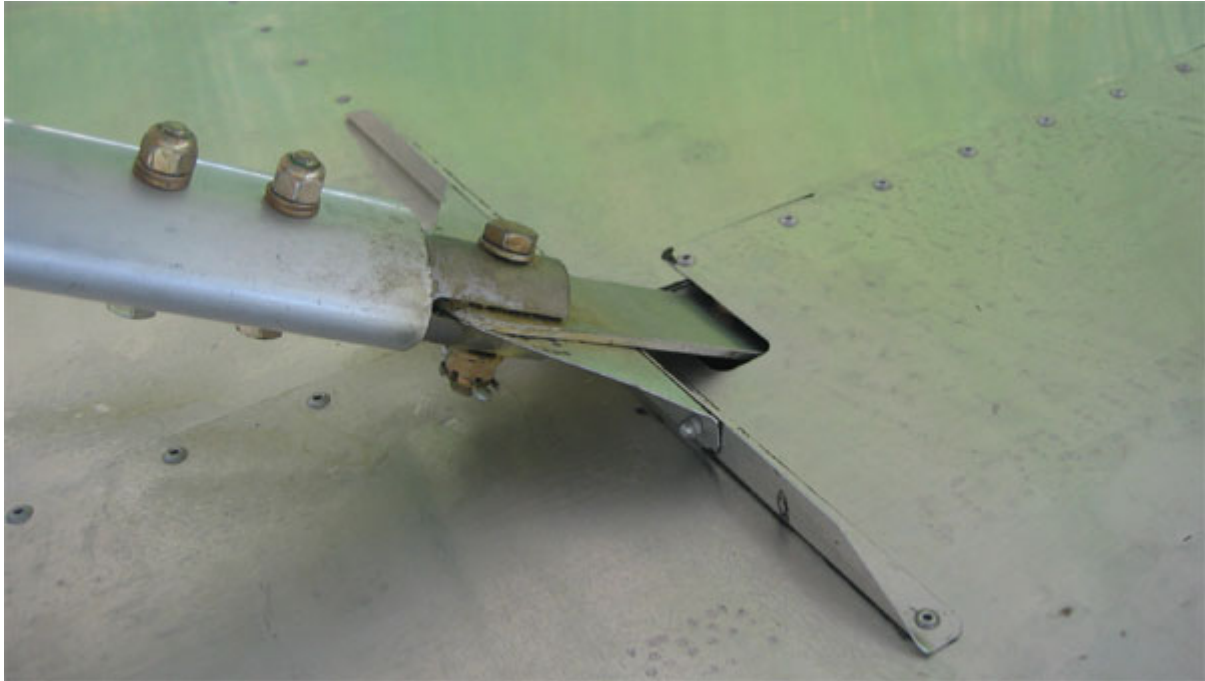
Picture 3: Similar as picture 1, but right-hand wing.

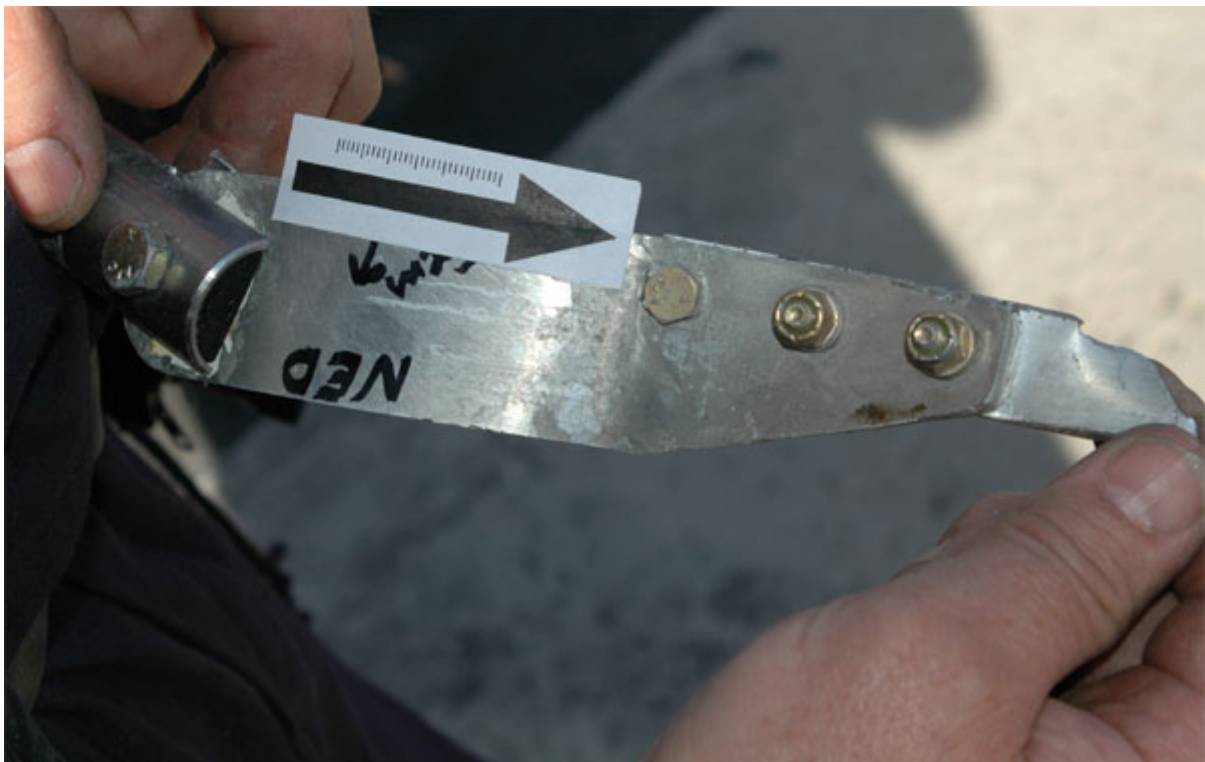
Picture 4: The right-hand wing of the wreck shows a crack at a similar place on the connection plate.

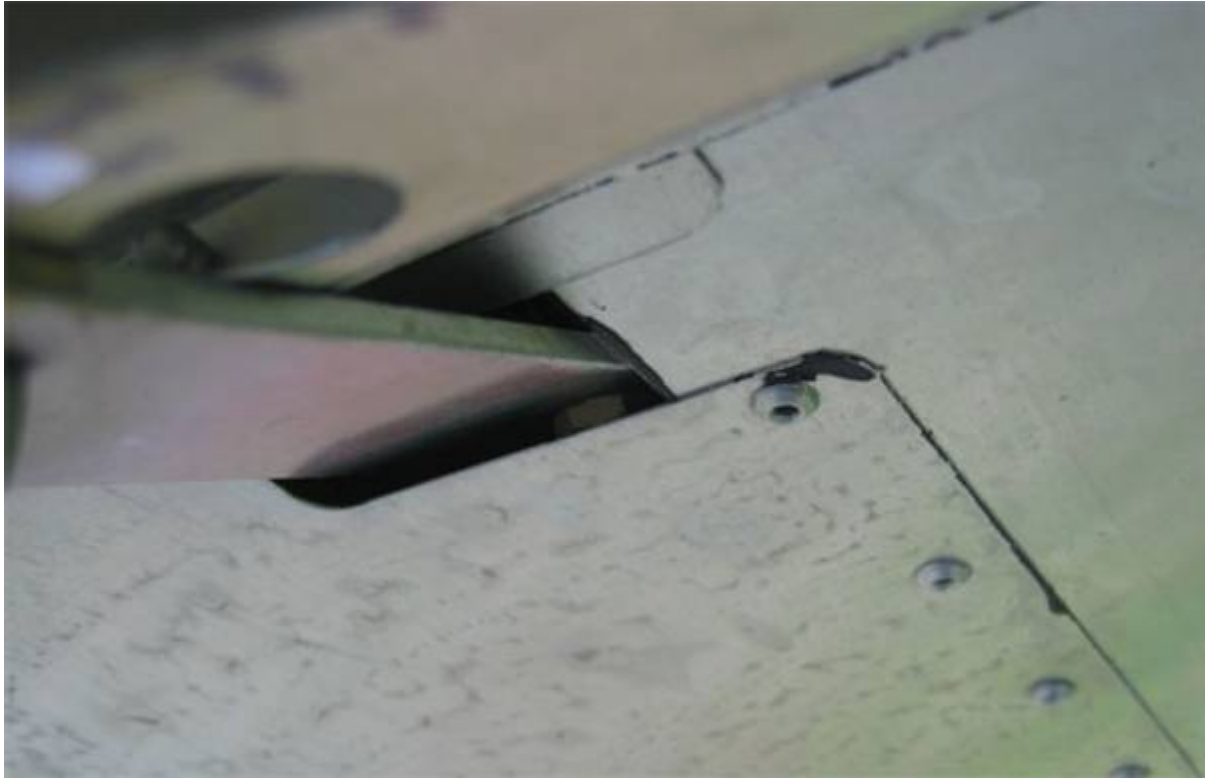
Picture 5: Inspection can be difficult through the narrow slot.
