EASA Safety Information Bulletin

SIB No.: 2014-34
Issued: 23 December 2014

Subject: **Possible Exceedance of Engine Temperature Limits of BRP-Powertrain Rotax 912 and 914 Engines**

Ref. Publication: BRP Powertrain Service Bulletin SB-912-066 and SB-914-047 (single document) dated 08 December 2014, or later approved revisions.

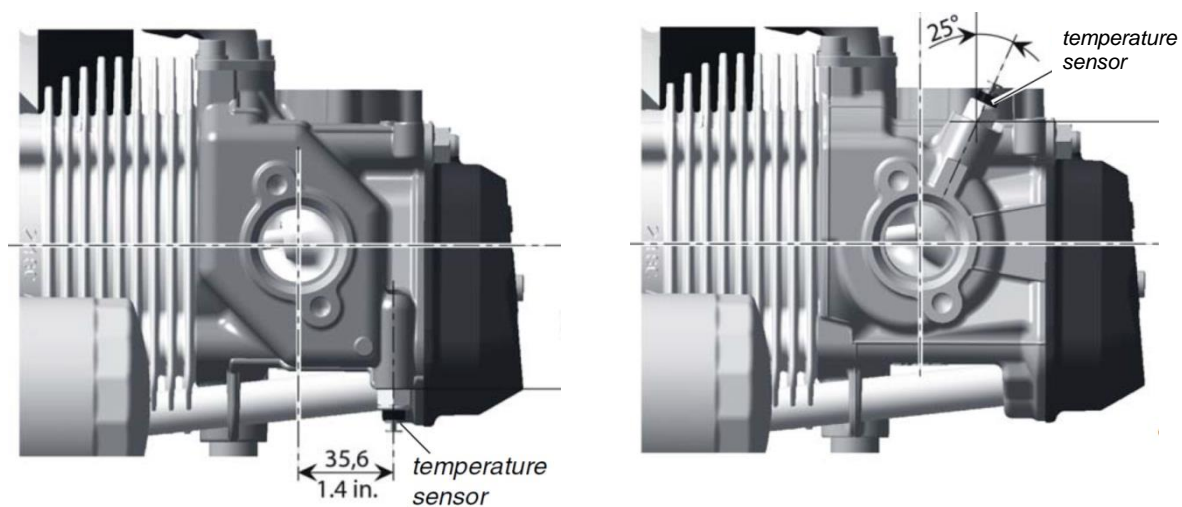
Picture 1 – CHT versus CT measurement

The reported conditions are the result of an insufficiently communicated engine design change which altered the engine/aircraft interfaces by substituting the previous cylinder head temperature (CHT) measurement (limit temperature 135°C/150°C) with a coolant temperature (CT) measurement (limit temperature 120°C).

This design change is currently not identified by the engine model designation or the engine P/N but only through the cylinder head P/N and the position of the temperature sensor:

CHT measurement → temperature sensor points downward
 CT measurement → temperature sensor points upward

If affected engines or cylinder heads have been or are installed during production or maintenance without concurrent installation of an adequate aircraft TC/STC holder approved modification, thus altering the previous aircraft CHT indicator/indicator markings/aircraft flight manual limitations, then coolant temperature with a maximum engine operating limit of 120°C (valid for engines operated with water diluted glycol coolant) is displayed on a CHT indicator with a typical limit marking (red radial/range) of more than 120°C. The pilot is therefore not able to identify coolant limit exceedances, subsequent loss of coolant and impending engine failure during flight.

Old cylinder head design, CHT measurement

New cylinder head design, CT measurement

- Identify if affected engines or cylinder heads, as specified in BRP SB 912-066/SB 914-047, have been installed on an aircraft during production since January 2013.
- Verify if the approved engine installation and the approved aircraft limitations are adequate to incorporate CT measurement instead of the previous design CHT measurement.
- Inform aircraft operators via the TC/STC holder publication system which actions, if any, are required to restore an approved design and to ensure a safe aircraft operation, or if no actions are required.

- Identify if affected engines or cylinder heads, as specified in BRP SB 912-066/SB 914-047, have been installed on an aircraft during production or maintenance since January 2013. This can be done through a review of the aircraft

records or through a visual inspection of the cylinder head design (refer to [Picture 1](#) in Annex 1 of this SIB).

- Before issuing the Certificate of Release to Service for an aircraft equipped with affected engines and spare parts as specified in BRP SB 912-066/SB 914-047, verify if an approved installation/modification is available from the aircraft TC/STC holder to install engines/cylinder heads with CT measurement instead of the previous CHT measurement.
- If no approved modification can be identified for the installation of affected engines or spare parts, do not install them and contact the aircraft TC/STC holder for further instructions.
