Reference: BMAA Service Bulletin 2462 Issue 2
Title: Inspection for material type – Control Cable Shackles and Elevator Joiner.
Applicability: All UK Sky Ranger, Sky Ranger Swift and Sky Ranger Nynja
Author: Paul Dewhurst, Flylight; Adrian Jones & Ben Syson, BMAA
Effective date: 1 December 2013
Classification: Mandatory

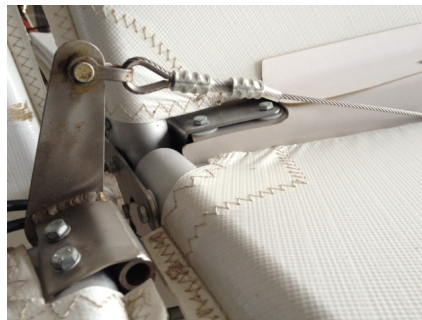
Elevator Joiner 124

A batch of non-optimum stainless steel alloy entered the production process for a limited time. This can result in a reduction of strength and cracking of the affected parts.

Elevator Joiner variants

If the Elevator Joiner is found to be cracked it must not be flown with and must be changed before the next flight.

If the Elevator Joiner is found to be of the wrong material (but not cracked) it must be inspected for cracks before every flight and replaced not later than 31 January 2014.

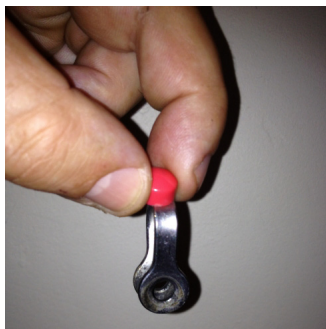
Shackle fails the test by being easily suspended by the magnet

- If the shackle shows no, or weak, attraction to the magnet such that the magnet cannot easily suspend it, the shackle is good.
- If the shackle has strong magnetic attraction such that the magnet can easily suspend it, the shackle is bad and must be replaced before next flight.

Use new split pins (ensuring correct size are used) on reassembly. After the Control Cable Shackles have been re-fitted, carefully check for correct reassembly, control sense, deflection angles and free control movement before flight.
