Ikarus Comco. Korkeusperäsimen työntötankojen laakerointi

SB-42-016-2013 Elevator Bearing Block

Inspection of elevator bearing block and exchange of the Polyamide distances.

All IKARUS C42 and C42 B to serial number 1301-7234

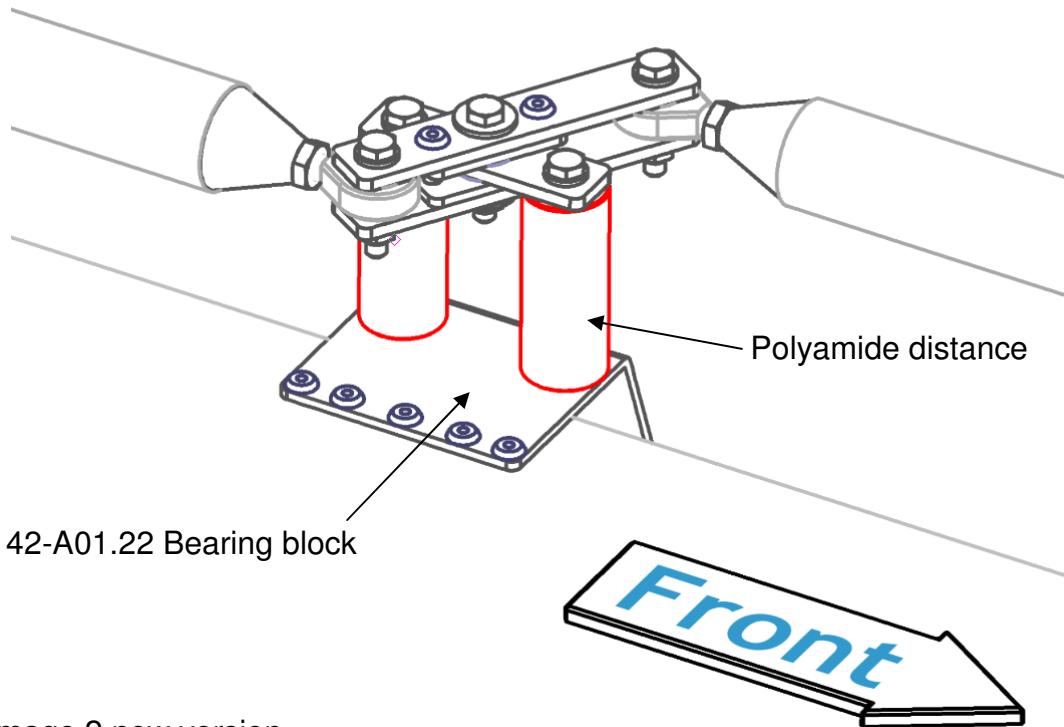
Image 1 previous version

By overloading on the ground (support on stick or elevator) or by clearance in the elevator linkage, the Polyamide distances can cause cracks in the bearing block.

Inspection of elevator linkage on stiffness and straightness of the Polyamide distances. Visual inspection of the elevator bearing block for cracks in the area of the bend. When in doubt, remove the screws securing the Polyamide distances for free accessibility of the bearing block.

Recommended: replacement of Polyamide distances by 42-A15.15A "stop distance elevator balance "(page 3: images 1 and 2)
