SERVICE BULLETIN

Owner's Service Bulletin – OSB 29 Issue 1

Applicability – Ikarus C42 all models

Inspection of main fuselage tube for cracking around cut-outs

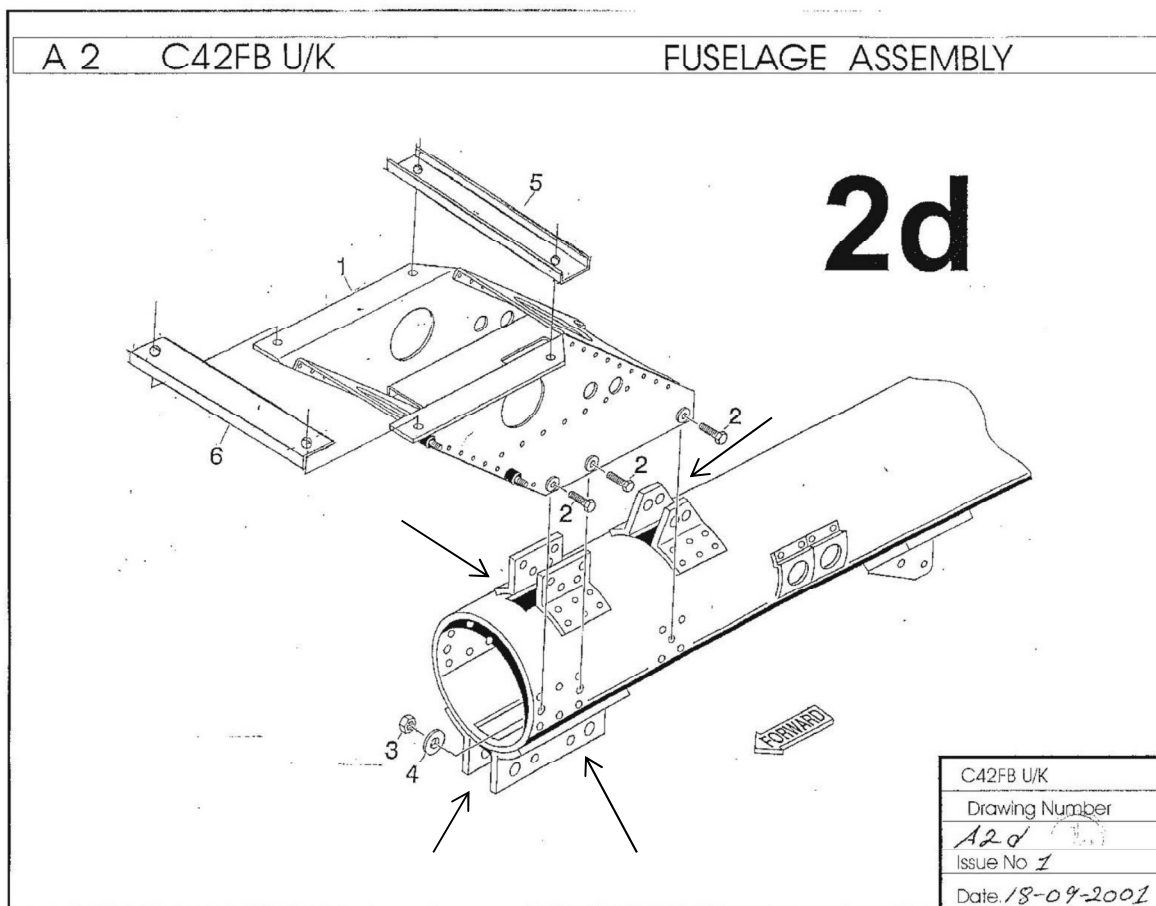
Nose-leg and A-strut cut-outs at front of main fuselage tube in vicinity of engine mount.

- Notes: 1. the stainless steel brackets securing the A-strut to the top side of the fuselage tube (the rearmost brackets shown above) were lengthened compared to those shown in the diagram above in around 2007, see the photo further below.
2. the holes for the A-strut attachment (the rearmost set of holes, one in the top of the main fuselage tube, one in the bottom) were eliminated entirely around 2015.

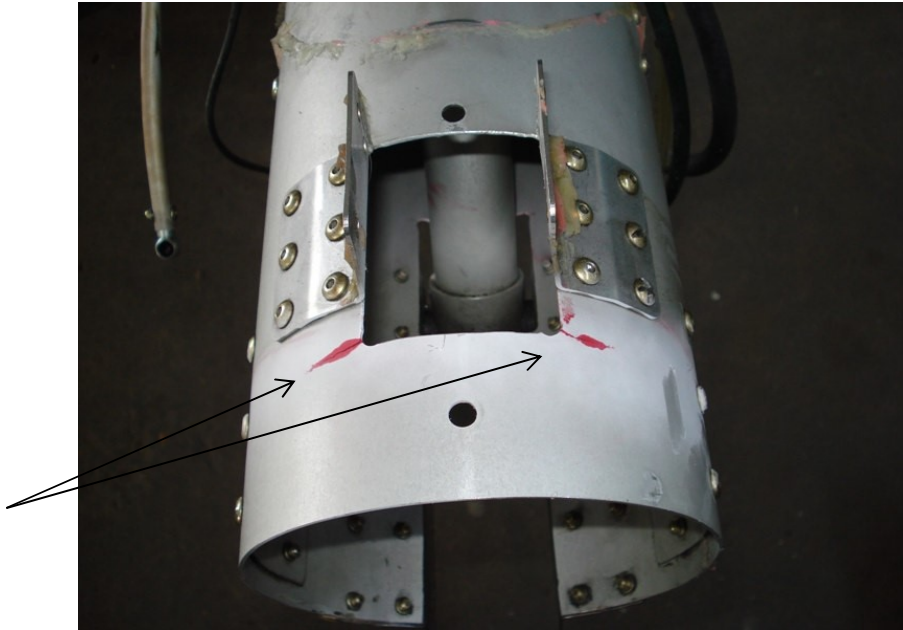
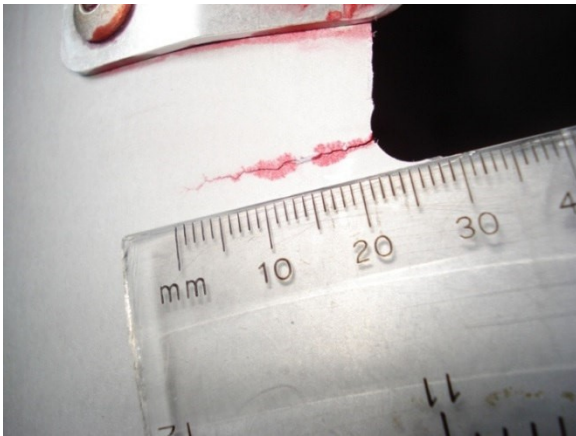
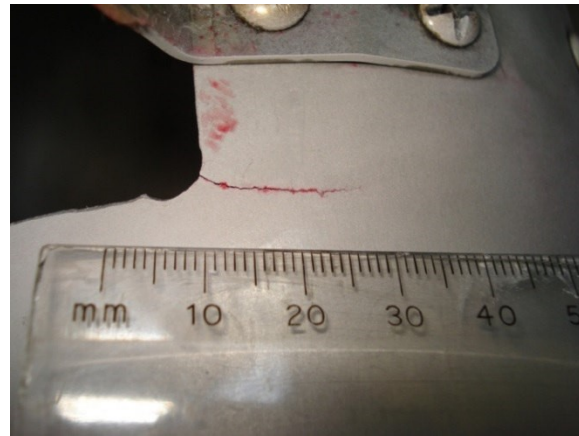
High hours examples of early C42 aircraft have exhibited cracks emanating from the corners of the cut-outs in the main fuselage tube where the nose-leg and A-strut are fitted.

Example cracks on upper surface of main fuselage tube at corners around nose-leg cut-out.

The perimeter of the cut-outs in the main fuselage tube where the nose-leg and A-strut pass through the main fuselage tube must be visually inspected for cracking, with particular attention paid to the corners.

If any cracking is found please contact Red Aviation. An approved repair scheme involving the fitment of an inner sleeve to the forward end of the main fuselage tube is available.

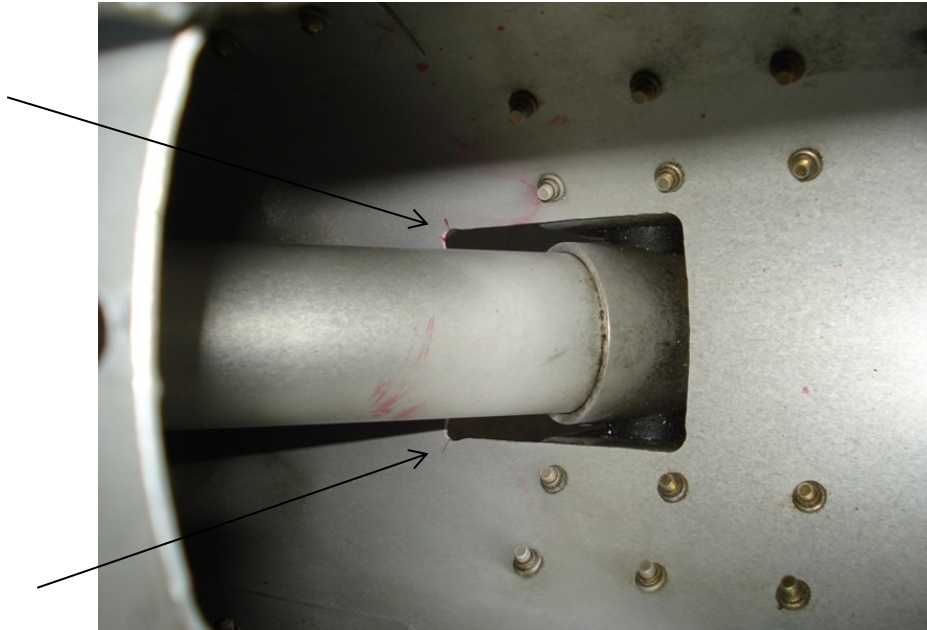
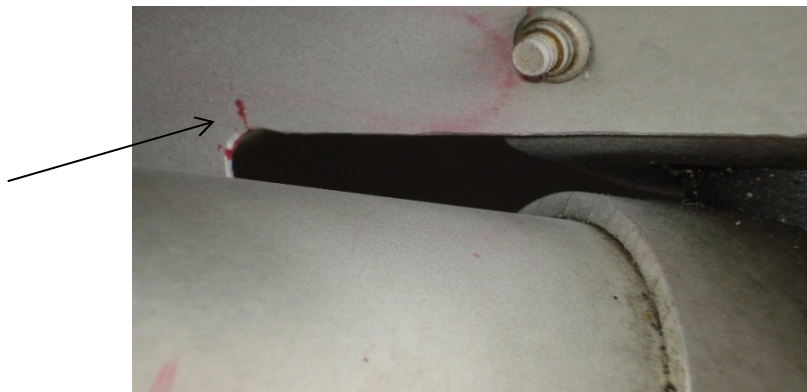
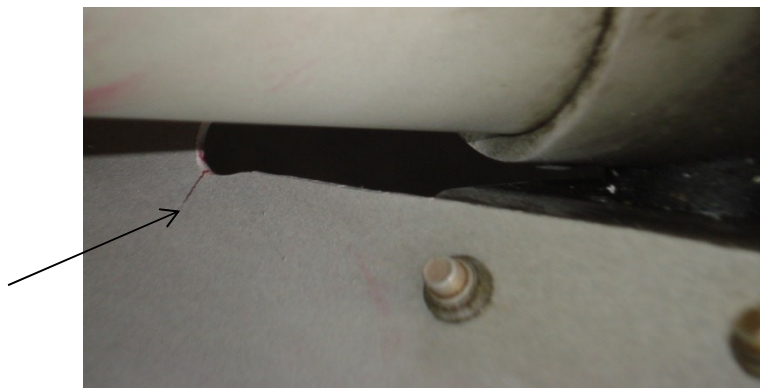
Example cracks on lower surface of main fuselage tube at corners around A-strut cut-out.

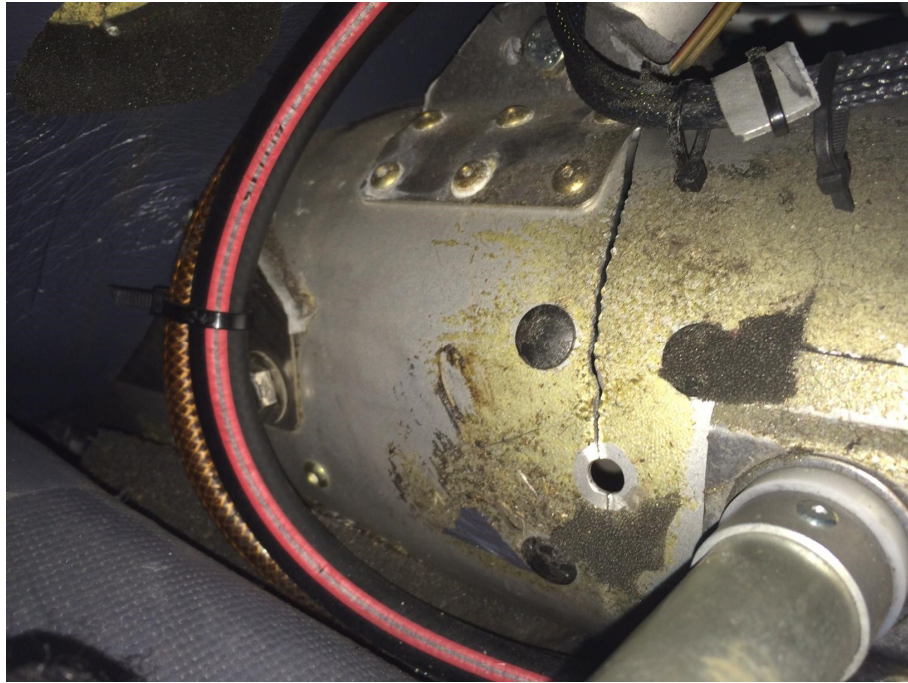
Example of significant crack allowed to propagate on 4500hr aircraft. This crack was hidden by the firewall sound-deadening foam. Ensure that it is removed for inspection.

Remove the area of sound-deadening foam on the cockpit side of the firewall which hinders inspection of the A-strut cut-out just forward of the rudder pedals on the top of the main fuselage tube. This is the area which concealed the significant crack shown in the example photographs above.

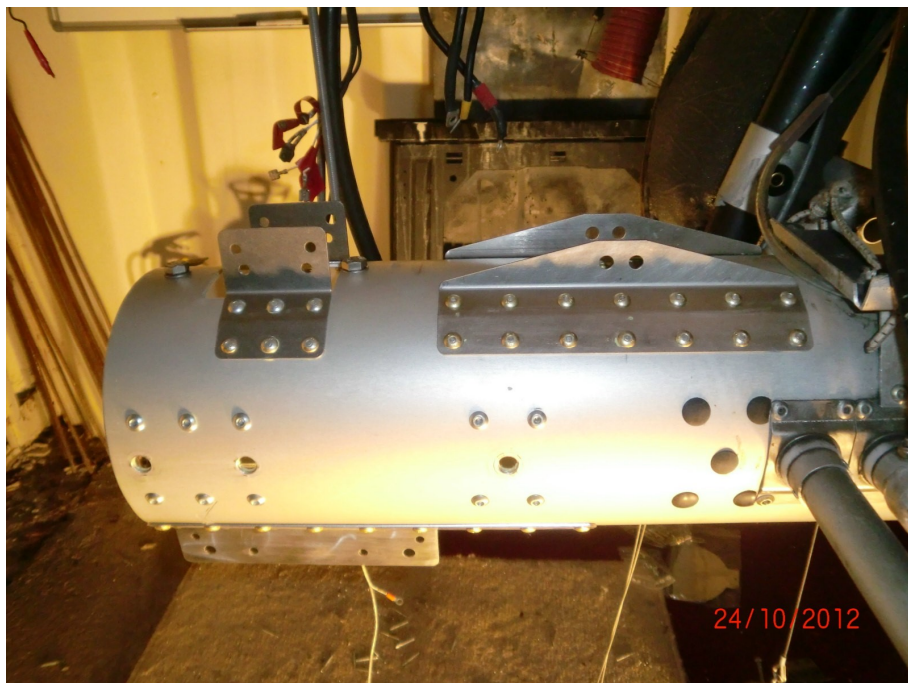
Lengthened A-strut top attachment brackets as found on aircraft from around 2007.
