Aerospool. Laskusiivekkeiden työntötankojen tarkastus

Koskee: Kaikkia niitä Dynamic WT-9-ultrakevyitä lentokoneita, jotka on varustettu tyypin A laskusiiveketyöntötangoilla..

Subject: Swing bearings and flaps push-rods check

Affected: WT-9 Dynamic, from S/No. DY-002/2001 till S/No. DY-200/2007. Does not apply to aircrafts equipped with flaps push-rod type B (see figure bellow)

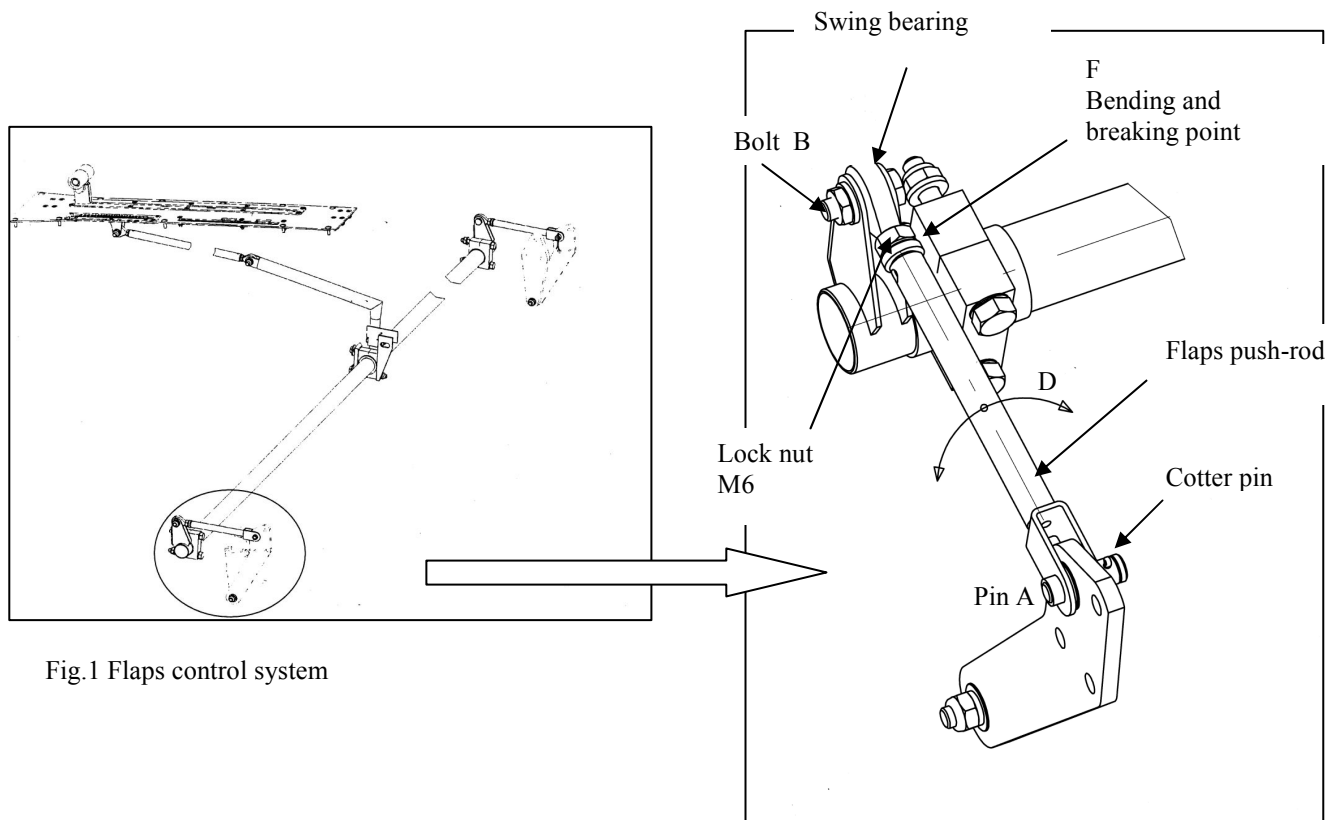
Fig.1 Flaps control system

Reason: Occurrence of bending and fatigue break of the swing bearing of flaps push-rod

Arrangements: The aim of the proposed measures is to check alignment of swing bearing with flaps push-rod on left and right flaps and thereby eliminate creation of conditions for the development of fatigue breakage due to bending loads

1. Extend the flaps to fully extended position (position flaps 3)
2. Remove the flaps push-rod by following procedure:
 - 2.1 Lock off pin A (remove cotter pin), fig.2
 - 2.2 Put out pin A
 - 2.3 Unscrew the nut of bolt B and put out bolt B
3. Measure and record the total length "d1" on removed flaps push-rod. (see bellow)
Measured value is necessary for reassembly

4. Release the lock nut M6 (fig. 2) and unscrew the swing bearing from flaps push-rod
5. Examine swing bearing (1) and flaps push-rod (2) alignment. Verify if the swing bearing is not bended at point F (see bellow)

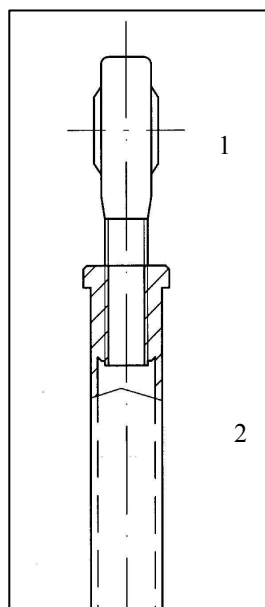
All right

Wrong

6. If the flaps push-rod is in alignment with swing bearing and bending of the swing bearing is not observed, screw swing bearing back to flaps push-rod
7. Set initial distance "d1", measured at I.3
8. Tighten the lock nut M6
9. Mount the flaps push-rod to aircraft in the inverse order as described in I.2
10. Lock pin A by cotter pin
11. Ensure that after flaps push-rod installation there is a free movement of push-rod when flaps retracted and fully extended (fig.2 position D)

1. If the misalignment of flaps push-rod with swing bearing or swing bearing bending was detected in I.5 then both parts, flaps push-rod and swing bearing, have to be changed for new ones
If any doubt related to the condition of flaps push-rod or swing bearing make the exchange for new ones or contact the manufacturer
2. Make installation of new original parts following the procedure described in I.6 - I.11
