Technical Advice No.13
June 25th, 2007

CTSW2006 model year 2006 and 2007

serial numbers 06-07-15 to 07-05-18 inclusive, when equipped with full span trim tab.

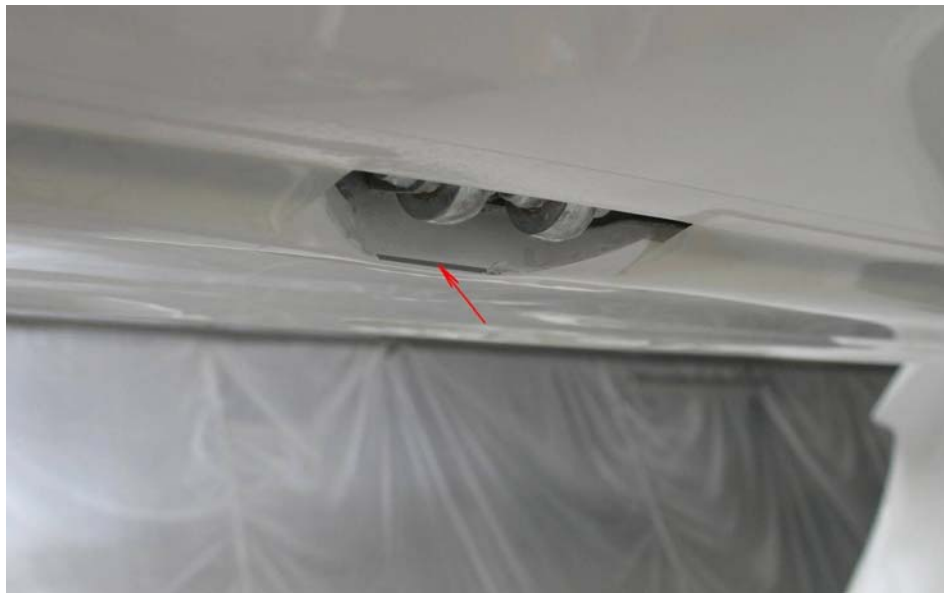
Fig. A: Inspection area: Trim tab control horn attachment point
(Seen from underneath the stabilator)

The investigation did determine that a pitch control vibration could result from the de-bonding of the upper and lower trim tab (anti-servo tab) skin exactly in the area of the Trim Tab Bracket (Part No. KA 3011110) as evidenced by a crack located at the attachment point. (Fig. A)

If cracks are found in the area of bonding (attach point) (Fig. A), the aircraft must not be flown until the mandated reinforcement procedure is completed.

Flight Design is mandating an immediate inspection of the Trim Tab Bracket attachment area, with special consideration of the trim tab composite structure. The inspection will be performed before the next flight and thereafter prior to the first flight of the day. When performing the

inspection, the trim tab has to be carefully loaded by hand in the middle area, in order to enable finding of small damages.

Regardless whether cracks are found, all aircraft listed in this Safety Directive are subject to the modification procedure within the next 25 flight hours, or at the next maintenance interval, whichever occurs first.

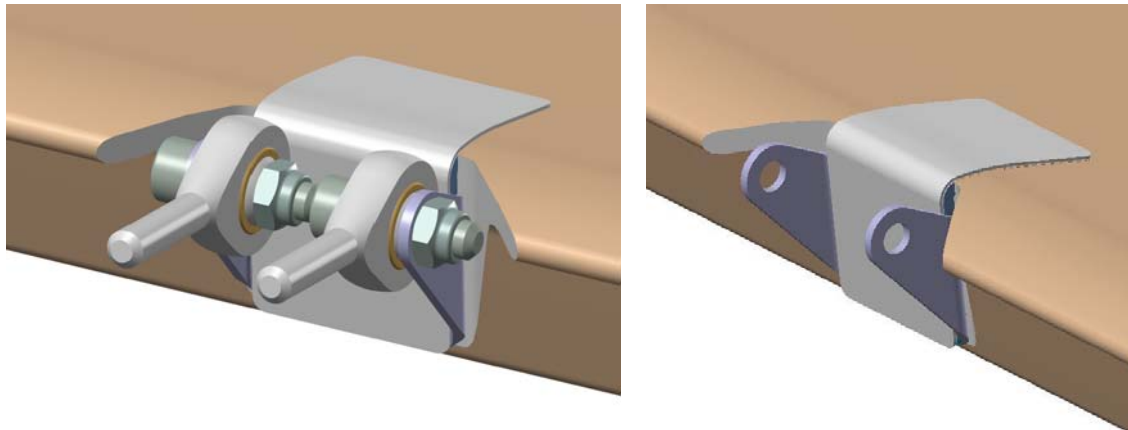
Fig B1 & B2: Reinforcement installed to the trim tab
(Tab shown bottom surface facing up)

The reinforcement procedure consists of reinforcing the point at which the control horn is bonded to the trim tab by the addition of specifically designed part manufactured by Flight Design (WA 3011011). The part is glued (bonded) to the control rod bracket and the lower trim tab surface and delivers a secondary load path for the trim tab control forces. The modification can be done without removing the trim tab, and does not require painting action. (Figs.B1 & B2)

The procedure shall be completed according to Flight Design document: “070625 – TRIM TAB REINFORCEMENT PROCEDURE” that accompanies this Safety Directive, and supplemented by the Maintenance Manual.
