**INFORMATIVE BULLETIN No. EV 97 – 014 b  
SPORTSTAR - 013 b**

1. **CONCERNING TO:** SportStar airplane (all models) as well as EV-97 EUROSTAR airplanes (all models except Model 97, Model 99).
2. **REASON:** It was found at operation, that some of the pilots, mostly less experienced, may unintentionally step simultaneously on both pilot's right and co-pilot's left pedal e.g. during hard landing, in result of which a ground controllability may be lost.

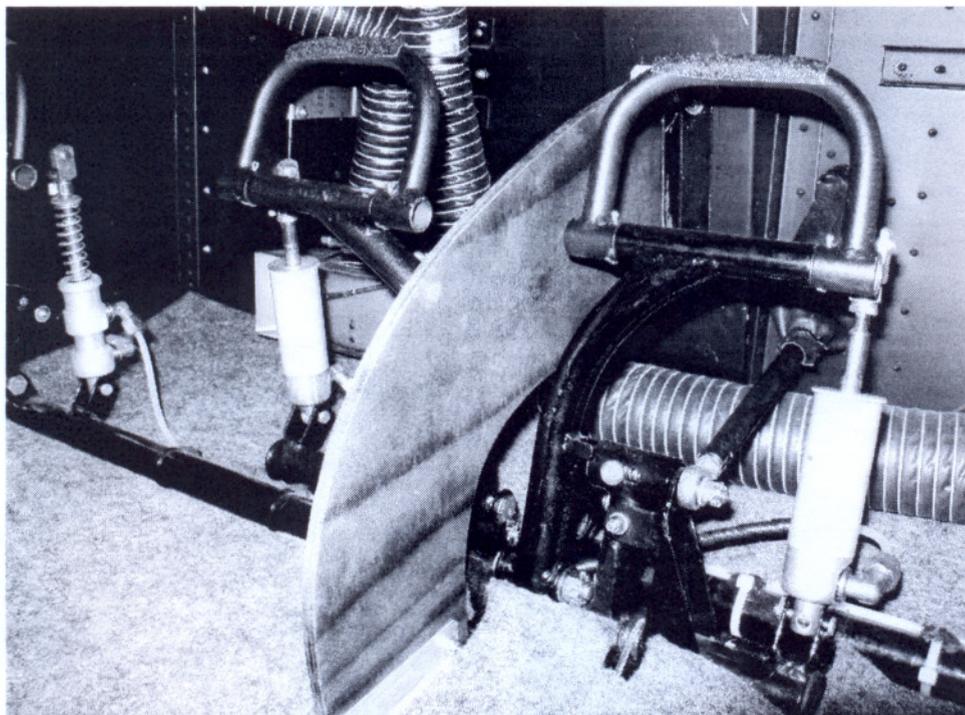
Appendix

Illustrative picture of the barrier between the pedals

3. **ACTION:** The airplane manufacturer offers sending of a retrofit kit to install a barrier between the pedals, which prevents from simultaneous depression of both pedals.  
In order to allow the barrier installation, replacement of the pilot's right pedal by a new one bent more might be necessary, as well as replacement of the co-pilot's left pedal by a new one bent more, especially at older models.
