Continuing Airworthiness Notice – 27-012

Avid and Kitfox Aircraft fitted with Flaperons

13 September 2018

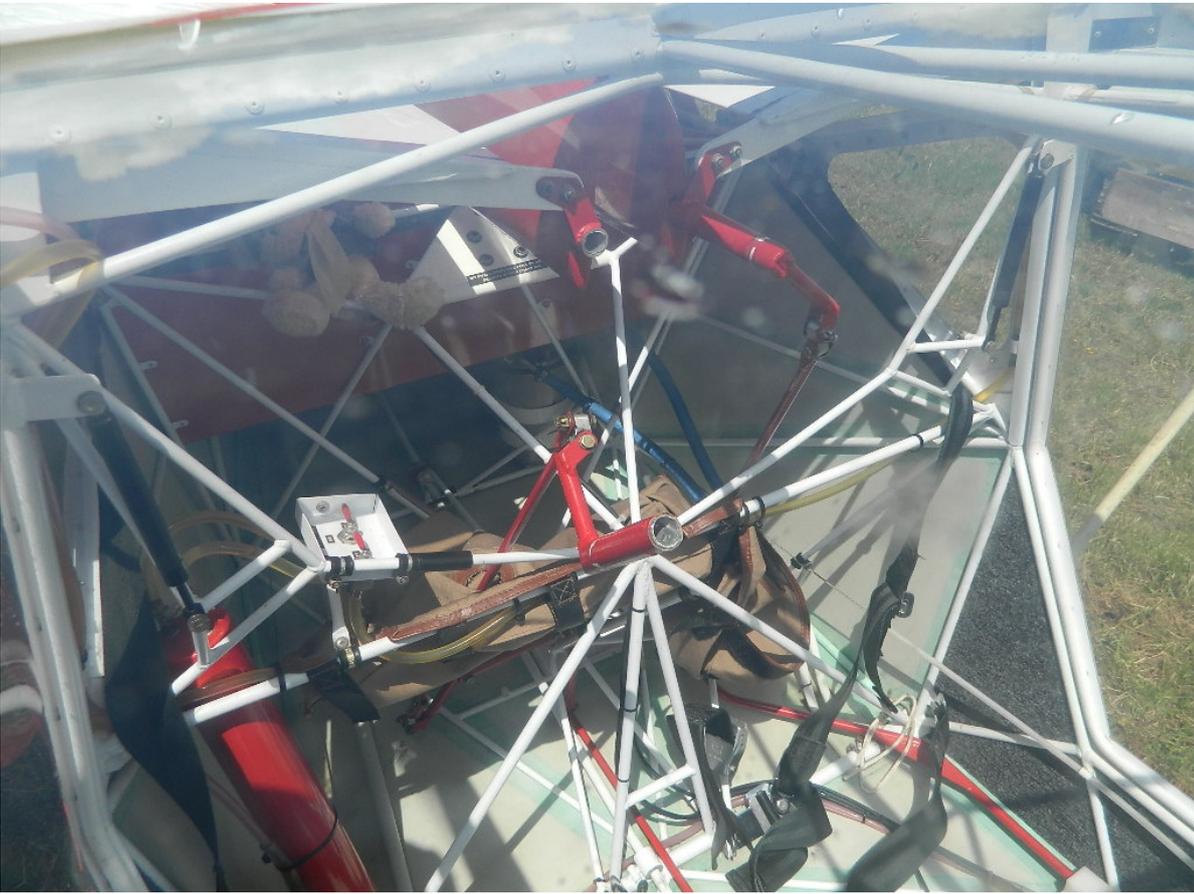
The flaperons on the accident aircraft have a 3/4 inch central aluminium spar tube with a joint where this tube enters a 4130 steel bellcrank. The aluminium tube at this joint was found snapped off, due to what appears to be corrosion and fatigue. For further detail refer to photographs 1 and 2 on the following page.

Photograph 1 – Starboard flaperon aluminium spar tube failure at the joint where this tube enters the 4130 steel bellcrank (Note: In these photographs the aircraft wings are folded).

Operators/maintainers of affected aircraft are encouraged to inspect the integrity of the flaperon control system on their aircraft for any defects, and more specifically for corrosion, which could result in failure and loss of aileron/flap control. Enquiries regarding this Continuing Airworthiness Notice should be made to:

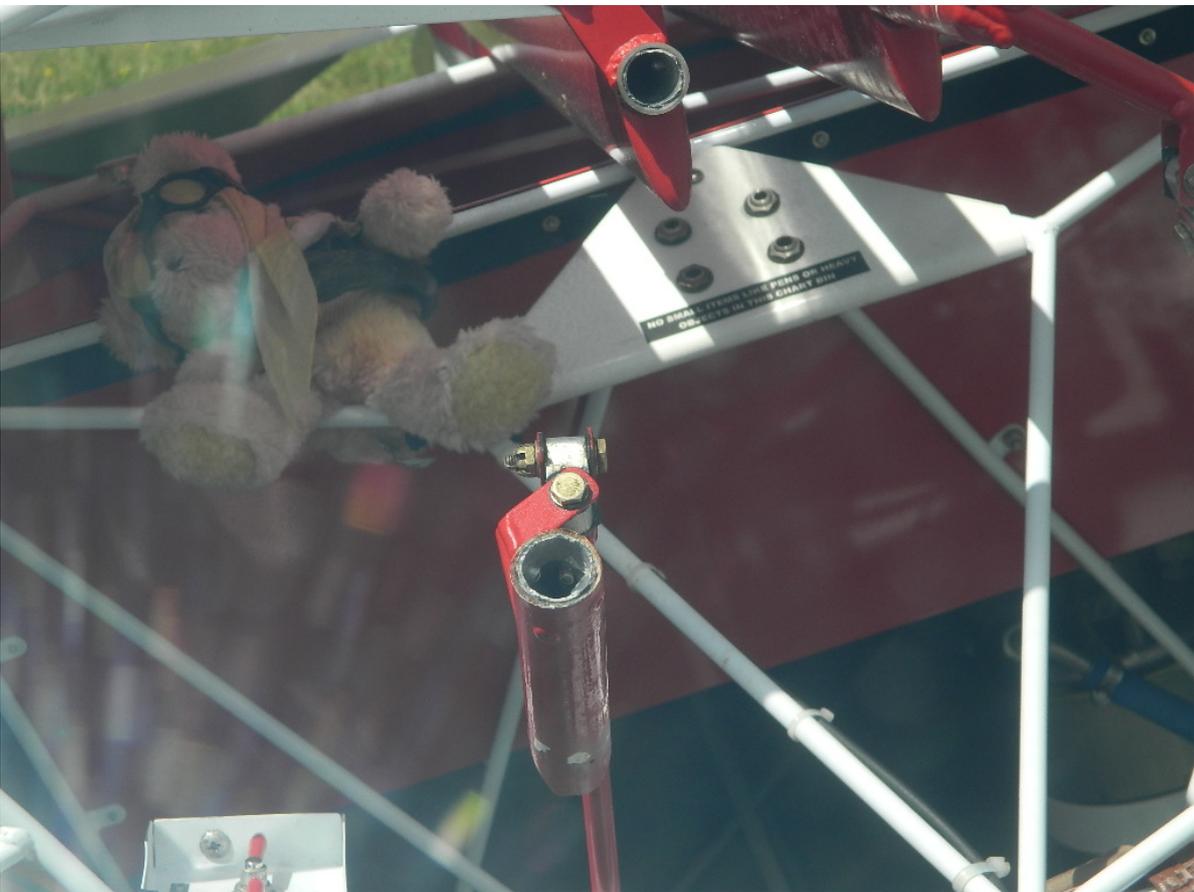
Photo 2 – A closer view of the failed starboard flaperon control rod.
